# ***Property Inspection Report***

**9710 23rd Way N, Palm Beach Harbor, FL, 33728**

**Date of Inspection: 4/20/2025**

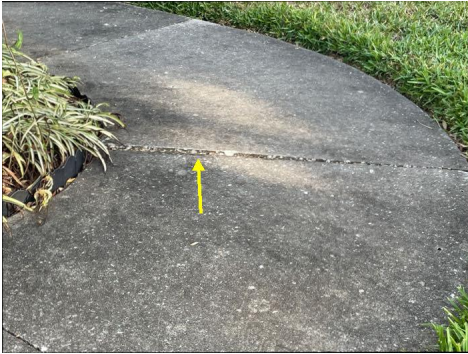
Driveway/Walkway surface was raised/settled. Trip hazard noted.

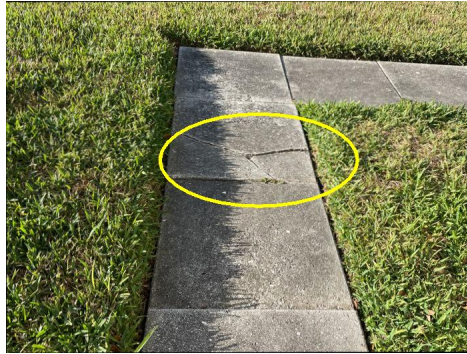
Walkway had large and displaced crack(s) visible.

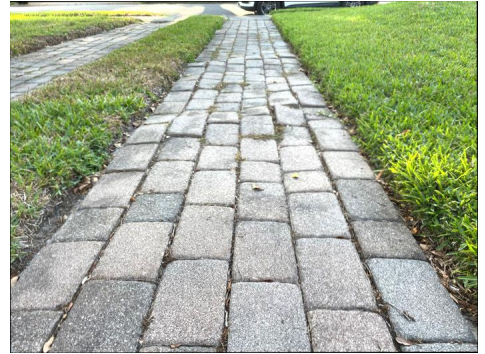
Driveway/Walkway surface was raised/settled. Trip hazard noted.

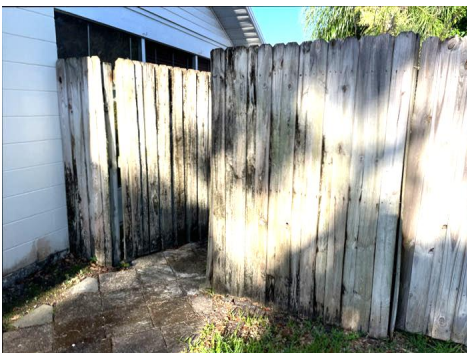
Fence were damaged.

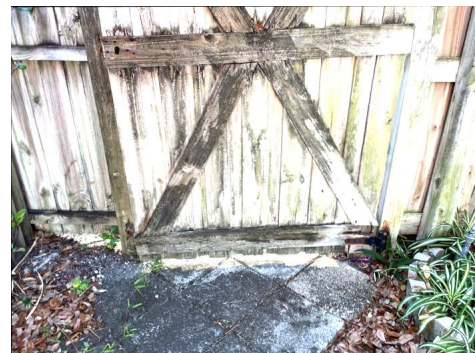
Gate(s) were damaged.

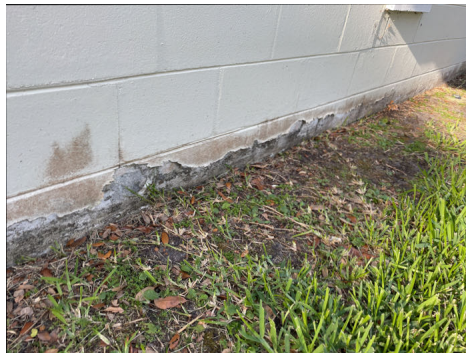
House should be painted in the near future.

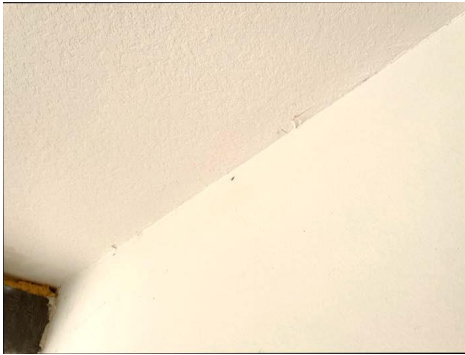
Ceiling seam separation was visible.

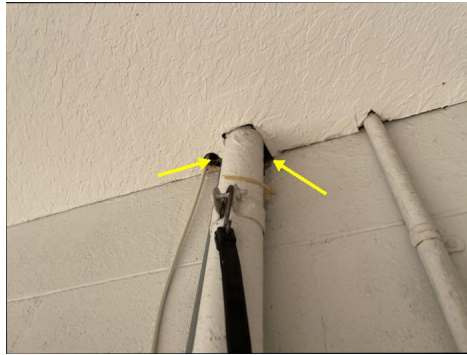
Holes/gaps should be repaired with fire-rated material.

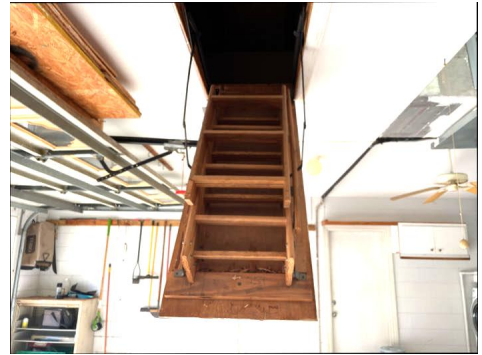
Attic pull down ladder was not fire-rated.

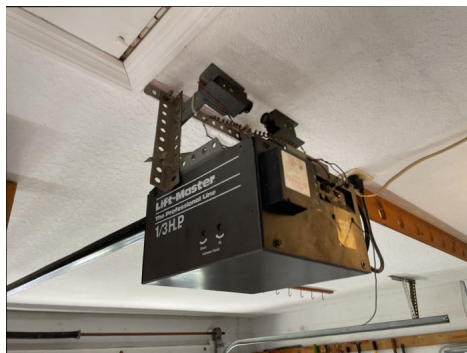
Electronic eye safety feature did not operate when tested.

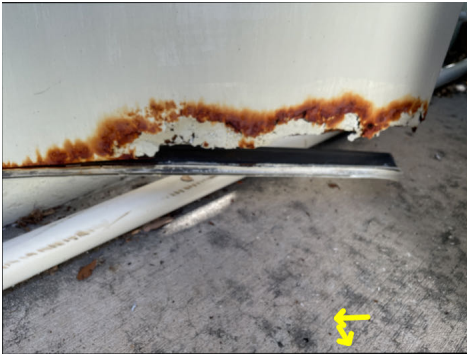
Moisture damage was visible at the door and/or door jamb.

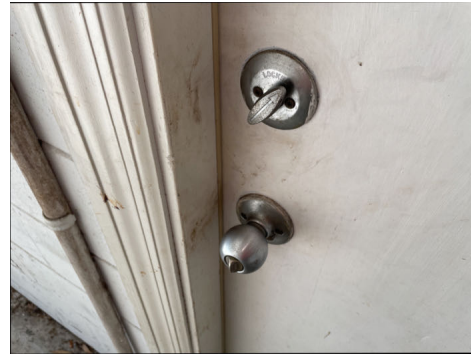
Lock was damaged.

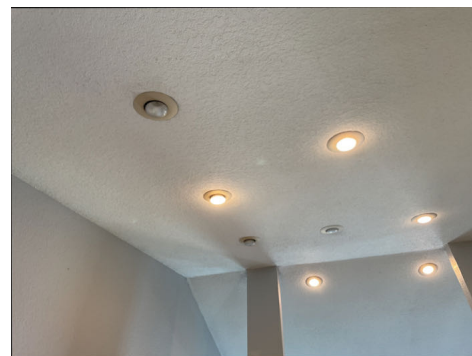
Light(s) were tested and not operational at multiple locations.

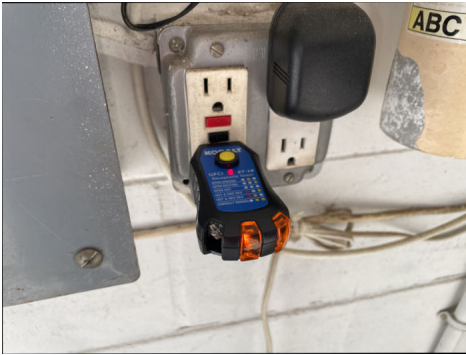
GFCI (Ground Fault Circuit Interrupter) outlet(s) was damaged at garage outlets.

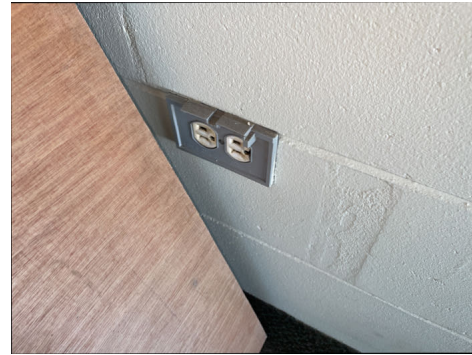
Weatherproof covers were damaged/missing at exterior outlet(s).

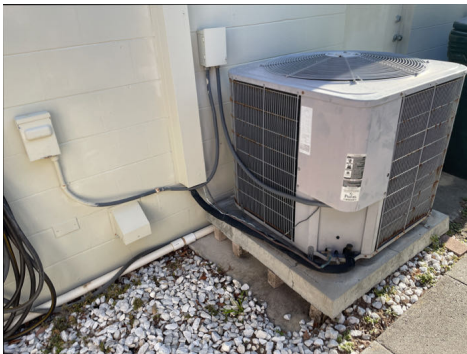
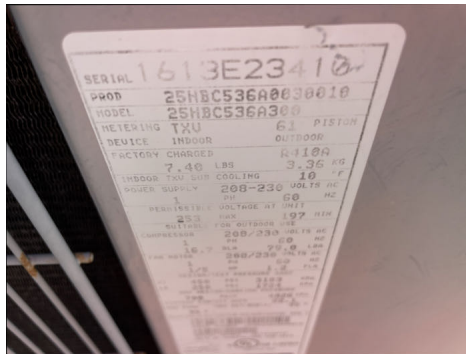
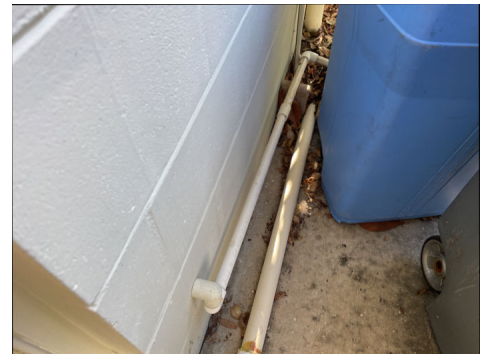
Proper trap was not installed at the condensation line.

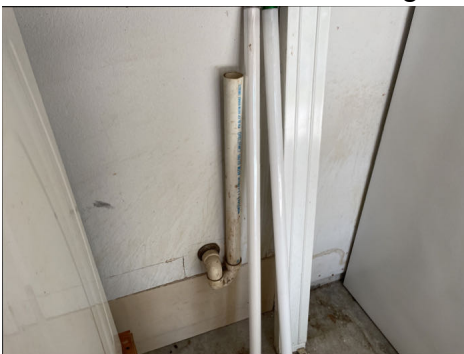
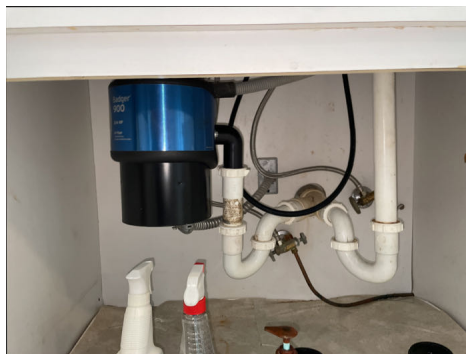
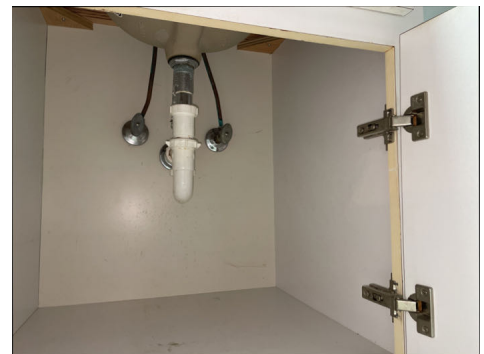
Unused sink drain in garage should be capped - dry trap, will allow sewer gases to escape.

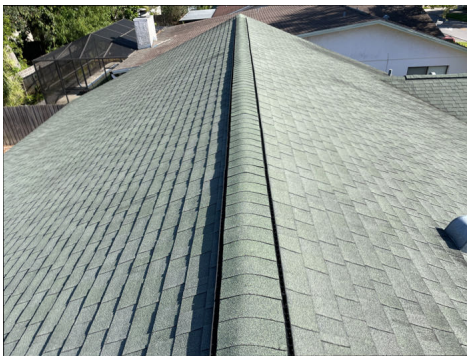
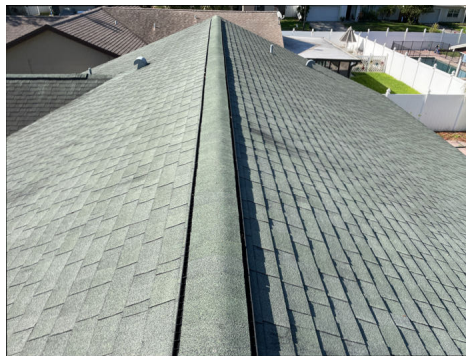
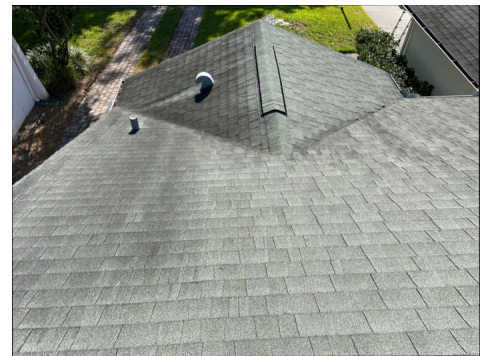
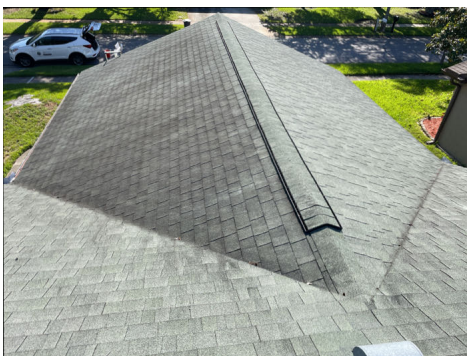
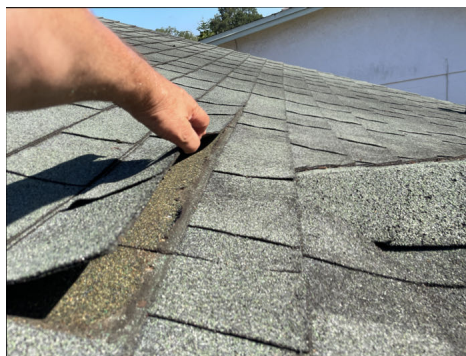
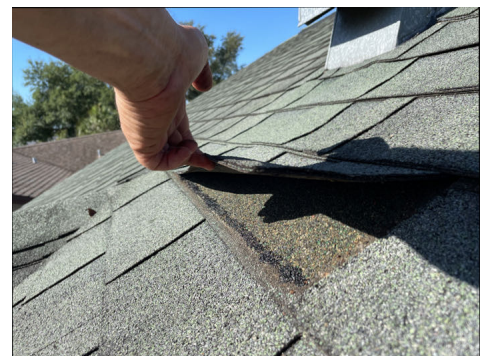
Damaged/Loose roofing material(s) were visible at multiple locations. An evaluation and repair should be completed by a qualified licensed roofer.

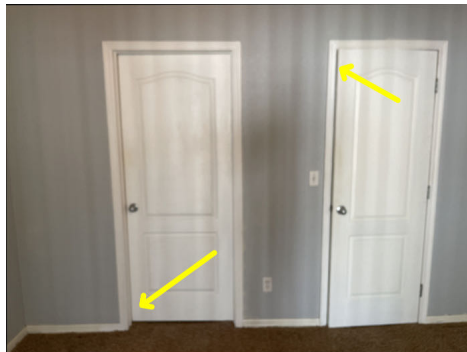
- Door rubbed/stuck at primary bedroom.

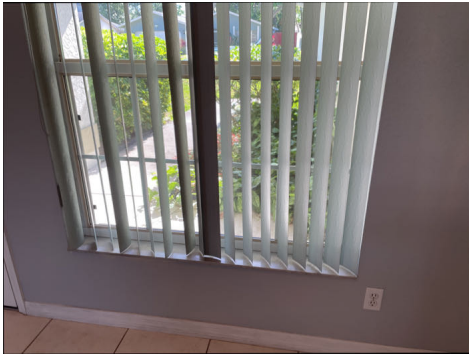
Window tension spring(s) were damaged at kitchen.

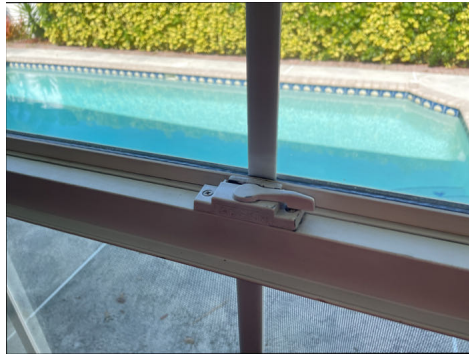
Locks were missing/damaged at family room.

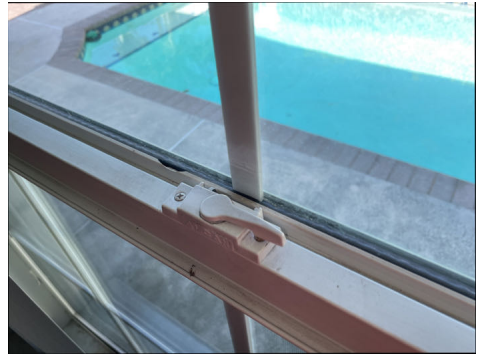
Locks were missing/damaged at family room.

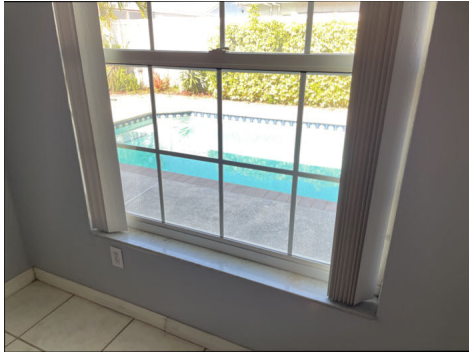
Window tension spring(s) were damaged at multiple locations.

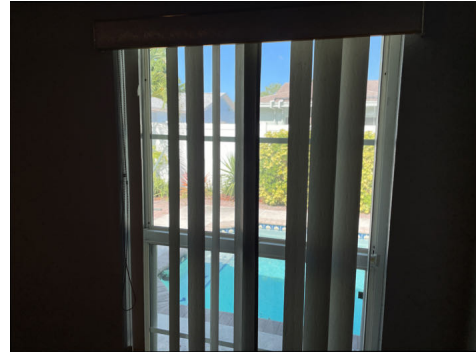
Window tension spring(s) were damaged at multiple locations.

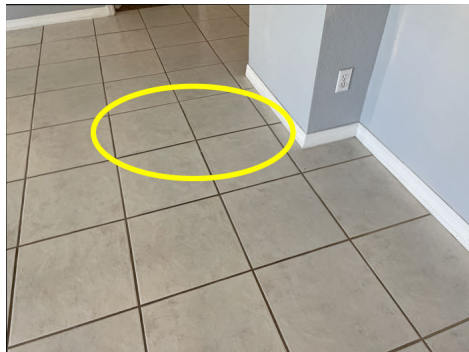
Tile flooring was disbonded at family room. Hollow sound can be heard when the flooring was tapped.

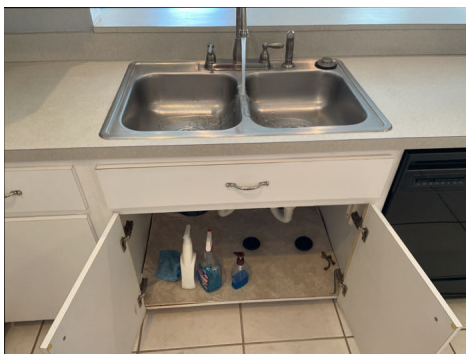
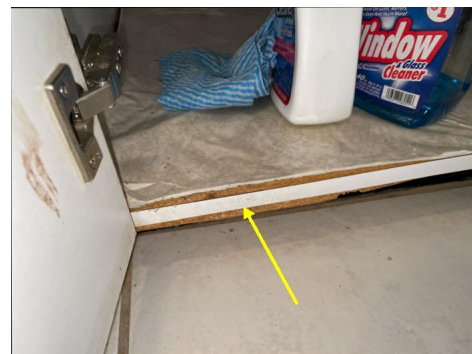
Moisture stains/damage was visible under sink.

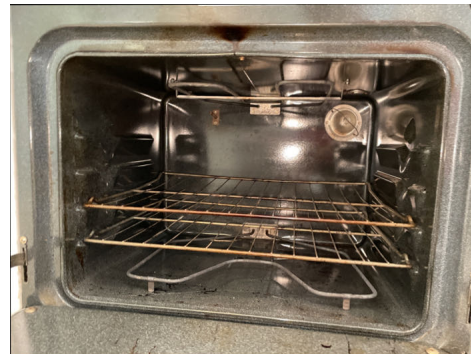
Oven was not functioning properly. No broiler. No Light.

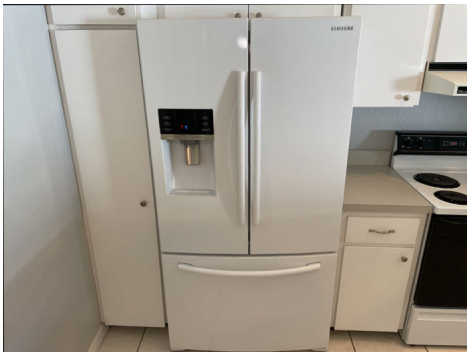
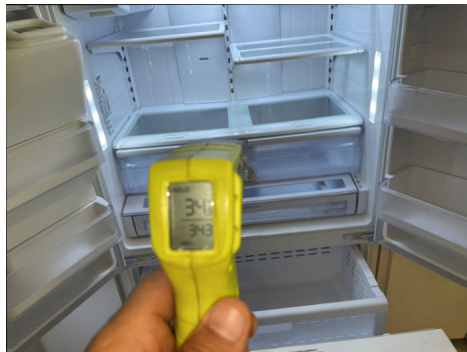
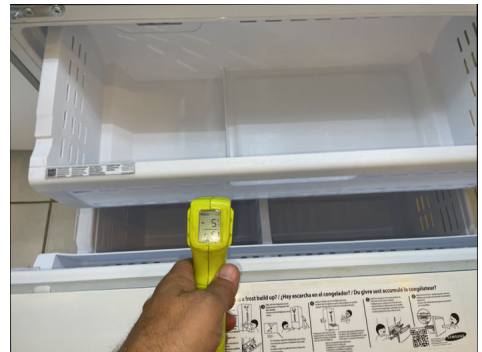
Refrigerator drinking water supply works, but icemaker did not supply ice.

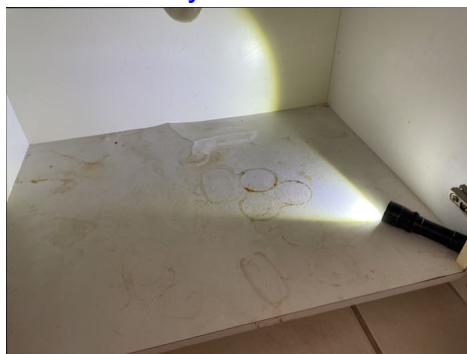
Dry stain(s) were visible under sink at hallway bathroom.

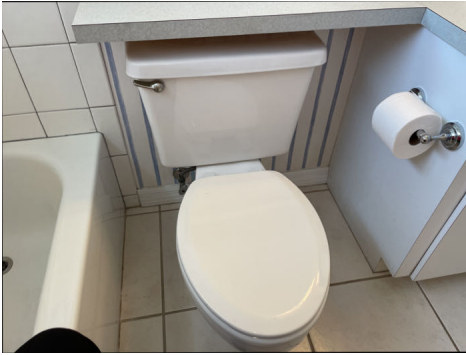
Toilet was loose at the floor at all bathrooms.

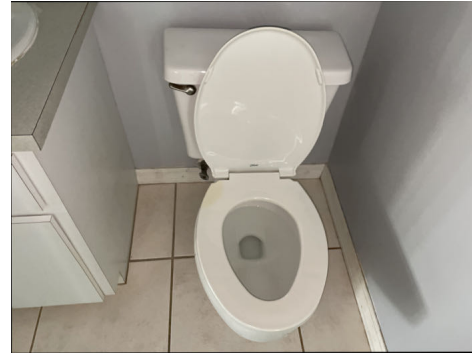
Toilet was loose at the floor at all bathrooms.

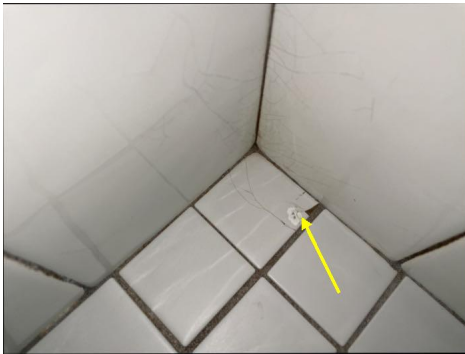
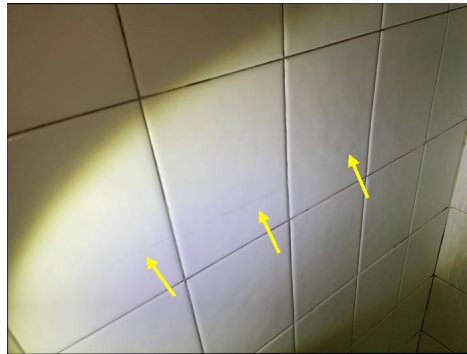
Cracked tiles were visible at primary bathroom.

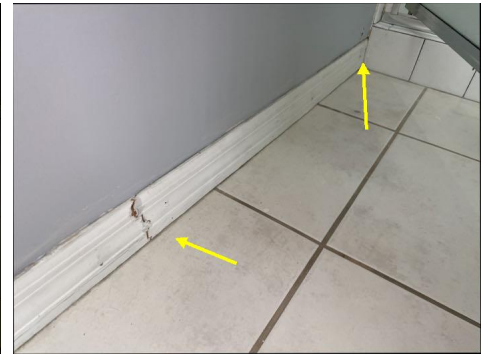
Wall at the exterior of shower enclosure was damaged at the primary bathroom.
