# ***Property Inspection Report***

**9710 23rd Way N, Palm Beach Harbor, FL, 33728**

**Date of Inspection: 4/20/2025**

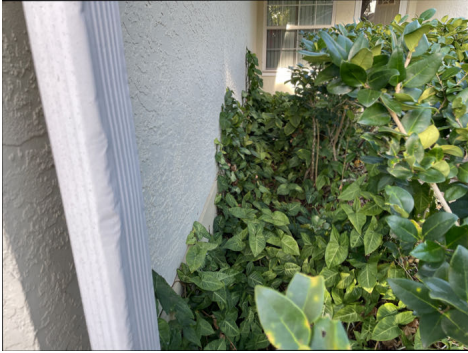
Landscaping and vegetation was poorly maintained and overgrown.

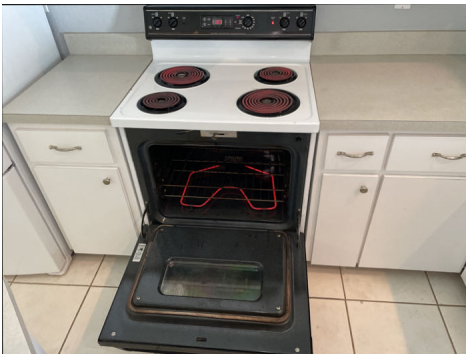
- Manufacturer: GE
- Power Source: Electric
- Oven light did not operate.
- Oven was not functioning properly.

Oven light did not operate.
