# ***Property Inspection Report***

**9710 23rd Way N, Palm Beach Harbor, FL, 33728**

**Date of Inspection: 4/20/2025**

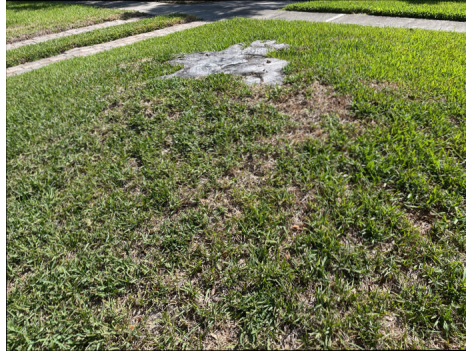
Two large tree stumps are present in the front yard

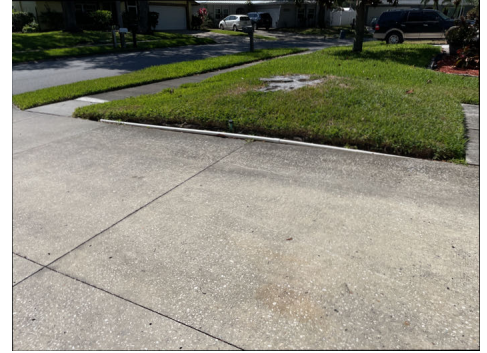
Two large tree stumps are present in the front yard

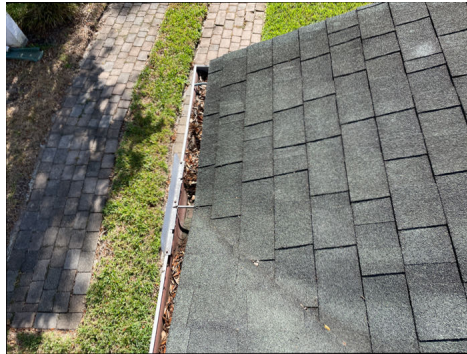
Gutters were filled with debris and the drains were blocked.

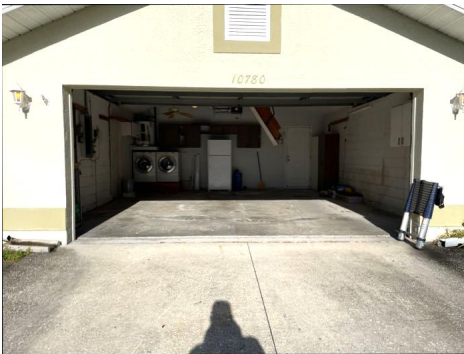
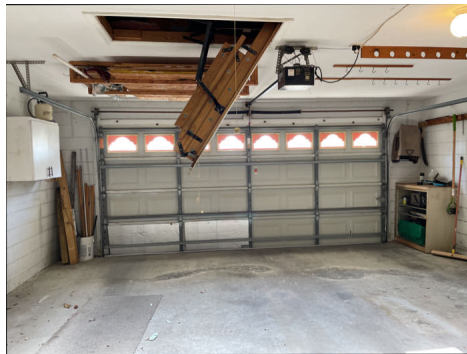
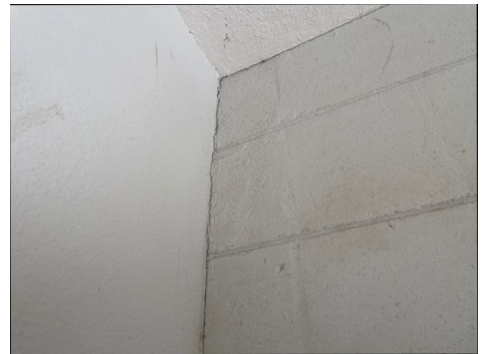
- Settlement cracks up to 1/8" inches were visible.

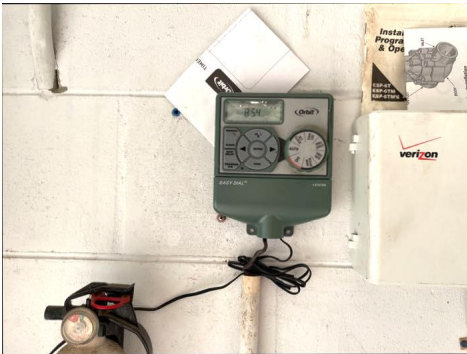
Sprinkler heads should be adjusted for proper coverage. Sprinkler spraying on structure and appliances.

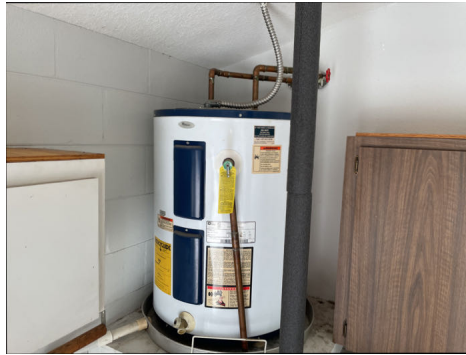
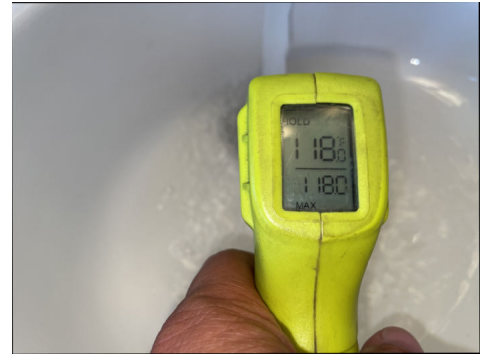
- Water heater was in good condition: Yes
- Water heater was near or exceeded the end of its useful life (10-12 yrs.) and may need replacement in the near future.

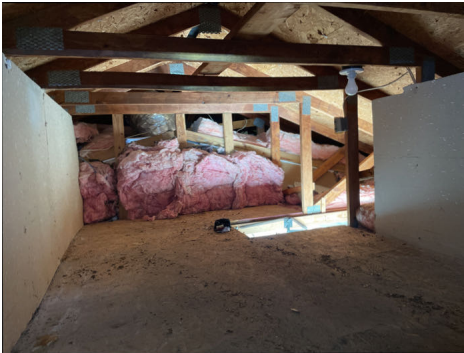
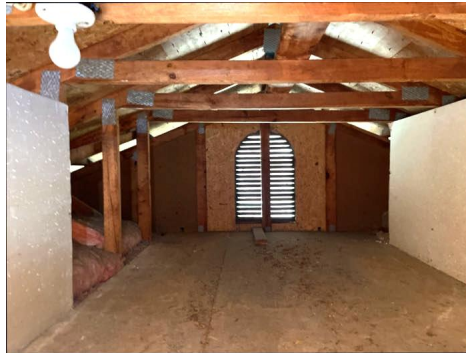
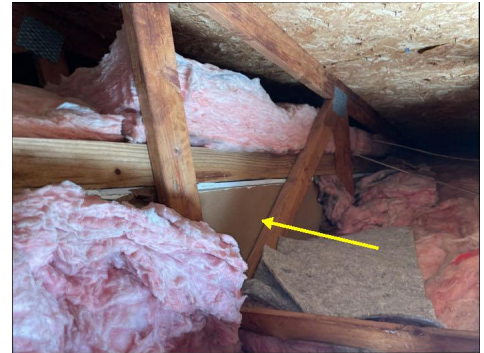
- Attic was not fully visible due to insulation, ductwork and height of structure.
- Insulation had been moved/disturbed, leaving low coverage areas.

Insulation had been moved/disturbed, leaving low coverage areas.

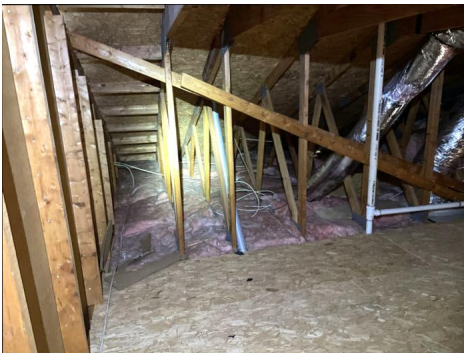
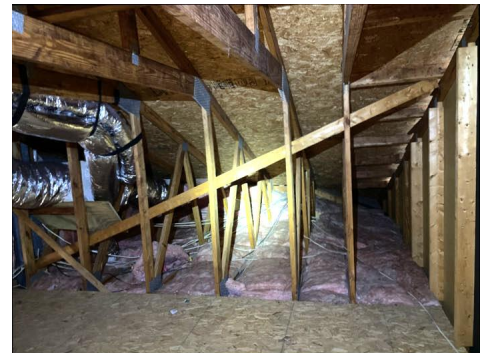
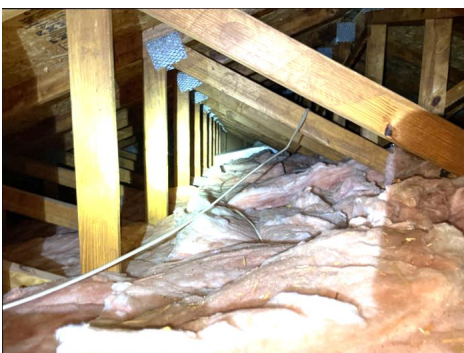
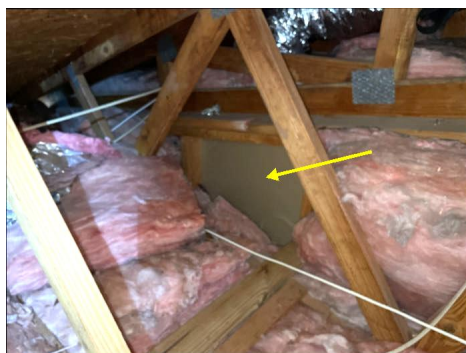
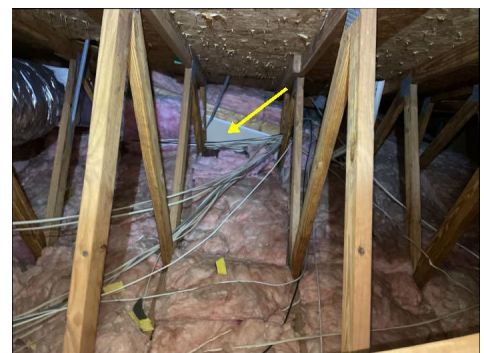
Insulation had been moved/disturbed, leaving low coverage areas.

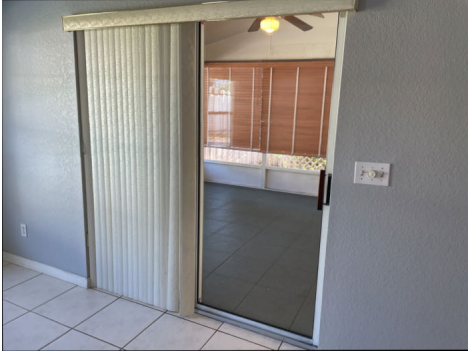
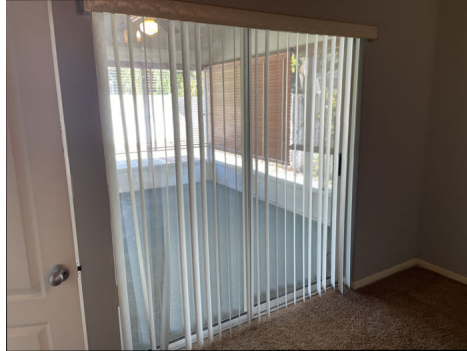
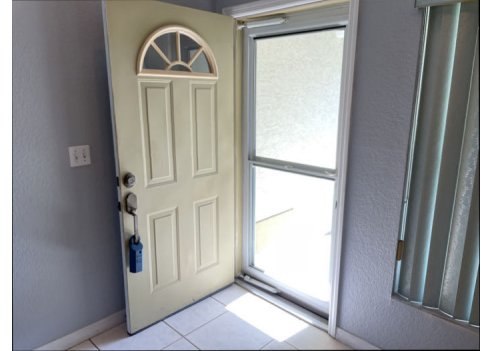
Tracks and rollers on the sliding doors should be cleaned, adjusted and lubricated for proper operation on a regular basis.

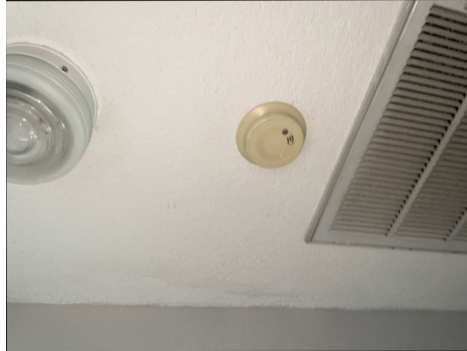
Smoke detector(s) did not respond when tested at Hallway.

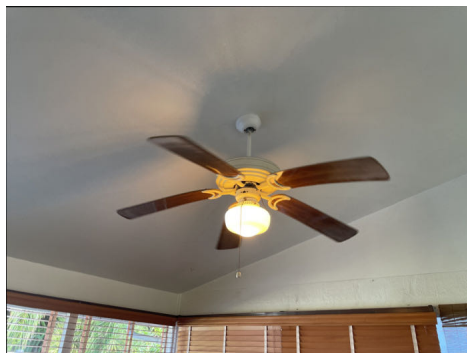
The ceiling fan(s) wobbled at the living/family room.

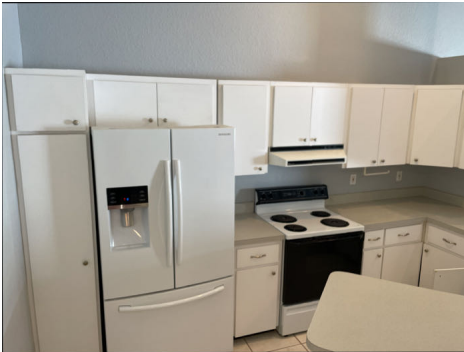
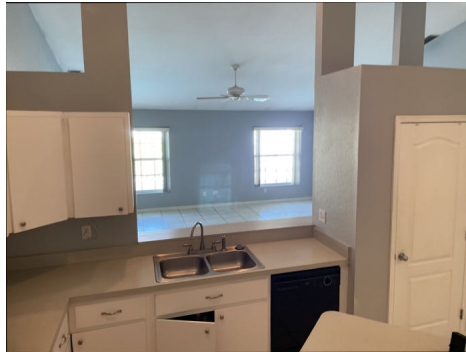
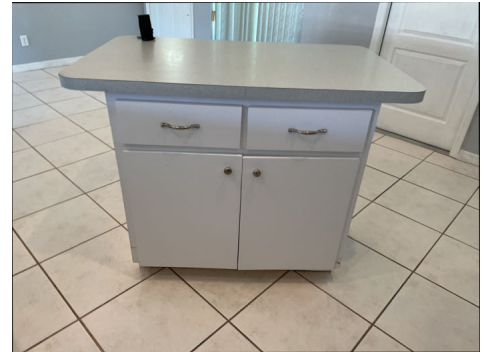
- Counter(s) were worn.

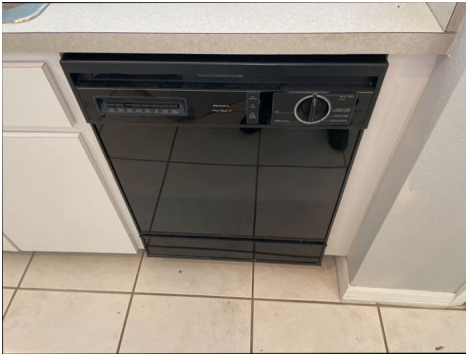
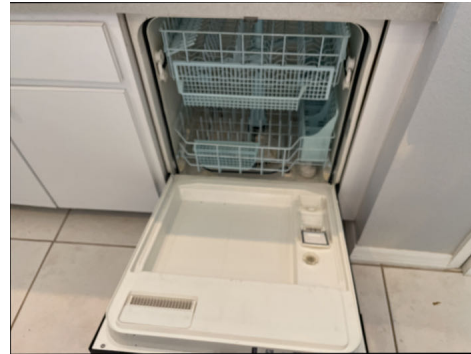
- Manufacturer: Kenmore
- Dishwasher did not operate under normal operating conditions.
